# MAINTENANCE MATTERS

**BC HOUSING**  
RESEARCH CENTRE

## At-Grade and Below-Grade Assemblies

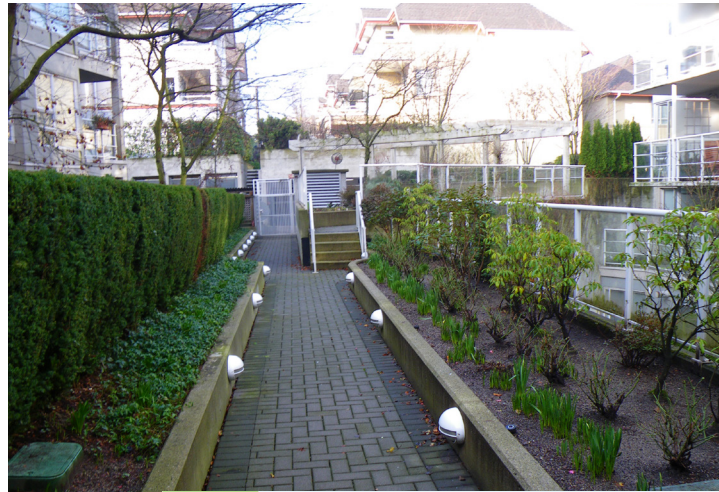
A typical courtyard at-grade assembly. This courtyard features many different types of overburden, making access to the underlying membrane difficult.

A typical at-grade assembly comprises overburden materials, a waterproofing membrane and a concrete slab forming the roof above the below-grade portion of the building. The concrete slab is often referred to as the podium. Examples of overburden materials include hard landscaping (patios, walkways, roads, stairs and planter walls) and soft landscaping (grass, shrubs and trees). Water features are also becoming increasingly common. Given these overburden features, it can be difficult and expensive to access the waterproofing membrane on the concrete podium slab for review, maintenance and renewal.

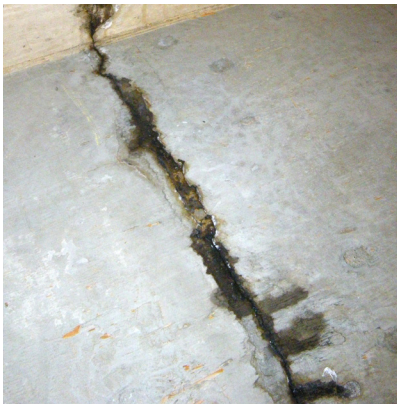
*Water ingress through a crack in the concrete slab*

redundancy on their own. For example, if the membrane has a small hole and the concrete is continuous, then leakage to the interior may not occur. Conversely, if the concrete has a small crack, the membrane may often bridge the crack and prevent water ingress. Over the life of the building, settlement, seismic movement and corrosion will act to induce cracks in the concrete structure. These cracks may sometimes extend up through the membrane and allow water ingress.

If it is not economical to access the membrane – and the extent of the water ingress, steel corrosion, and concrete delamination is acceptable – water ingress can be managed by sealing the leaking cracks in the concrete from the interior. A qualified contractor can be retained to inject the crack with epoxy or urethane, or the crack can be routed out and sealed with hydraulic grout. The goal is to try and push the injection material through the crack in the concrete and through the discontinuity in the waterproof membrane so that a seal is made on the wet side of the membrane. This provides the maximum protection for the reinforcing steel. However, care must be taken not to blow the waterproofing membrane completely off the concrete with the pressure of the injected material, thus creating an even larger path for water ingress.

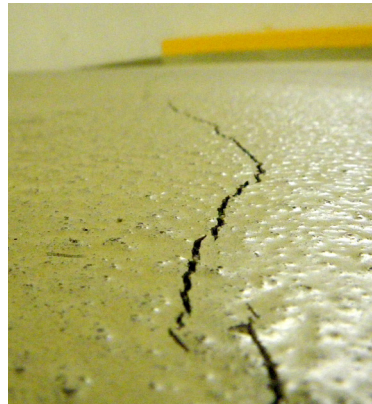
*Cracks in a suspended concrete slab membrane*

Unlike membranes on the podium and the foundation walls, the polyurethane traffic membrane on suspended concrete slabs is visible and can easily be reviewed and maintained. This system should be reviewed annually for signs of distress, such as tears, cracks, delamination and discolouration. Distressed areas, or areas with water leaks, can be repaired by a qualified contractor. The main areas of wear are typically drive isles and turning areas. In these areas the wearing surface, consisting of the top layer with embedded granules, will wear down over time. It is important to inspect this layer and renew it on an as-needed basis to prevent damage to the relatively fragile waterproof portion of the membrane below.

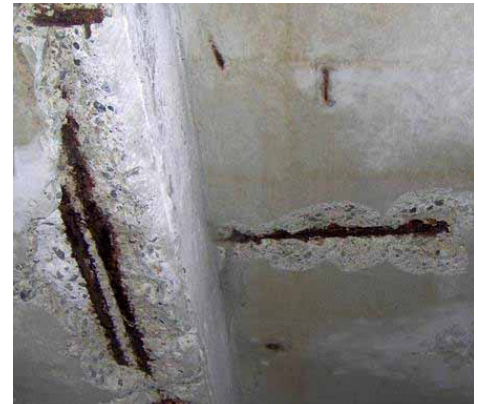
*Corroding reinforcing steel and delaminated concrete*

Water ingress is an indication that maintenance is required. If left unchecked, the constant flow of water through the concrete will bring moisture to the reinforcing steel, which will eventually result in corrosion of the steel. In the short-term, this corrosion results in rust staining on the interior surfaces. Rust staining is an indicator that maintenance is required. If maintenance is not carried out at this time, the corrosion may eventually expand and cause the concrete covering it to delaminate, spall and dislodge. Spalling and delaminating concrete can be dangerous to occupants, cause damage to property and is an indication that maintenance is required immediately.

Annual reviews for water ingress should also be conducted. If water leakage has caused visible rust stains on the concrete, the areas around the stains should be sounded by tapping the concrete with a hammer and listening for hollow sounds. Hollow sounds indicate delaminated concrete. If water ingress is increasing in frequency and severity, or if concrete delamination or spalling is occurring, a knowledgeable contractor or consultant should be retained to investigate the issue.

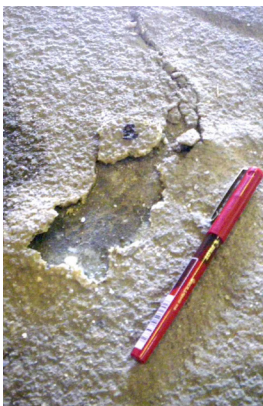
*Delamination of suspended concrete slab membrane*
