# MAINTENANCE MATTERS

## Managing Internal Water Systems

Water leaks are often the source of damage and insurance claims in multi-family buildings. Routine inspections, maintenance, renewals and resident notices will reduce the frequency of claims and losses.

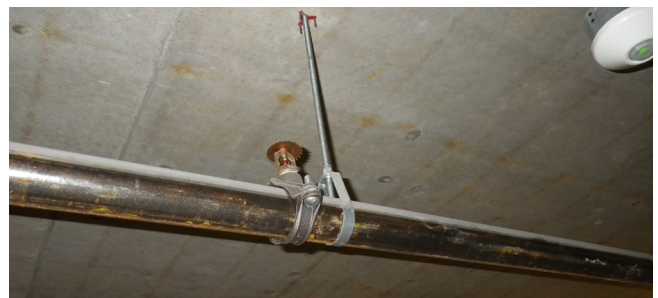
*Example of a pipe mounted sprinkler head in a dry fire suppression system in the garage of a multi-unit residential building*

Exposed sprinkler heads have a high risk of damage from impact or misuse as hangers. If your building has exposed sprinkler heads, installing cages is a small cost to prevent catastrophic failures.

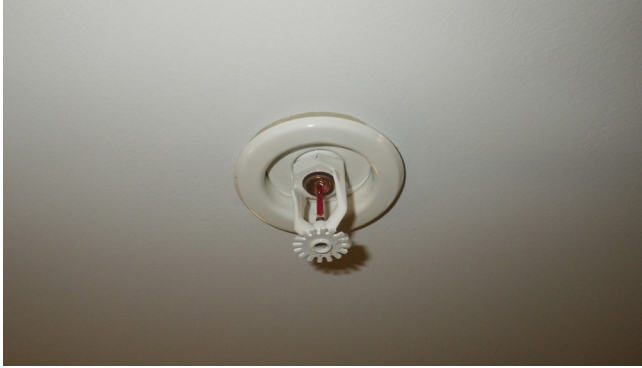
*Example of a ceiling mounted sprinkler head in a wet fire suppression system*

Wet systems are typically pressurized, so if the technician detects a pressure drop, it indicates a leak. The party responsible for building maintenance can determine what type of fire suppression system a building has. It doesn't matter if the system is wet or dry, residents must be informed to never hang anything off the sprinkler heads or lean anything against them.

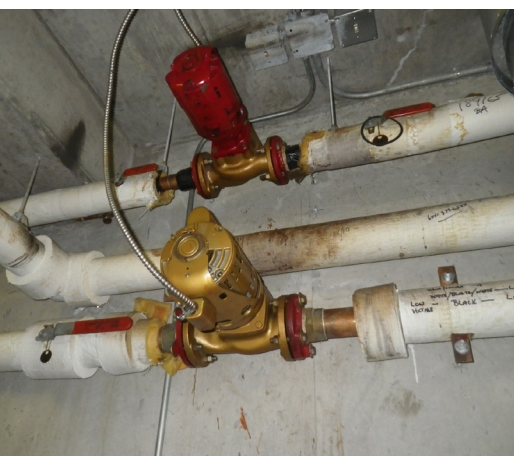
*Pipe-mounted domestic hot water circulation pumps recirculating hot water from system*

**Recirculation pumps** typically run 24/7, which adds wear and tear on the pipes. Adding a programmable timer and schedule on the recirculation pump for domestic hot water can help add service life and reduce energy consumption. The effectiveness however, is dependant on the type of building and water usage patterns. It should be properly commissioned when installed to reduce the need to reset the timers.

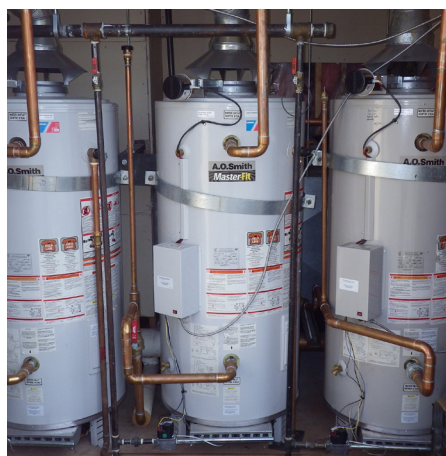
*Example of natural gas fired water heaters for domestic hot water use*

Hot water is typically managed in **storage tanks**, sometimes integrated with hot water heaters. It is most common for hot water tanks to be located centrally with piping distribution to each unit. However, hot water tanks within units are part of the strata lot and are the responsibility of the owner to maintain and repair. This makes it difficult for the strata corporation to control.

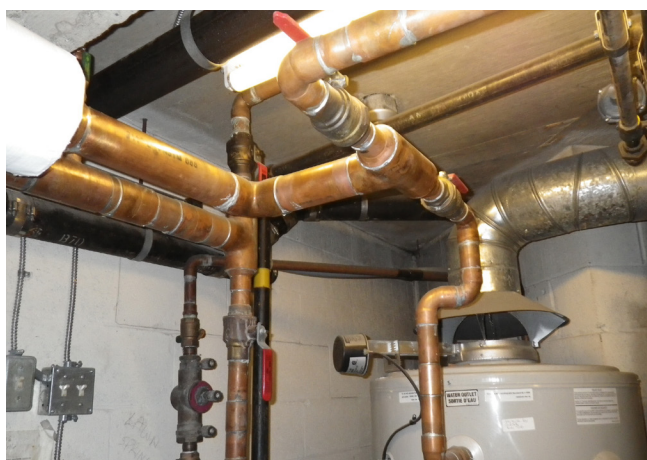
*Example of uninsulated copper piping*

Copper is a common material for water piping in buildings, however it does not last indefinitely. Replacement or re-lining of copper pipes will typically be necessary during the service life of multi-unit buildings in B.C. Copper pipes can last up to 50 years, but they thin out as they age, leading to pinhole leaks. Some municipalities have water quality that will speed up

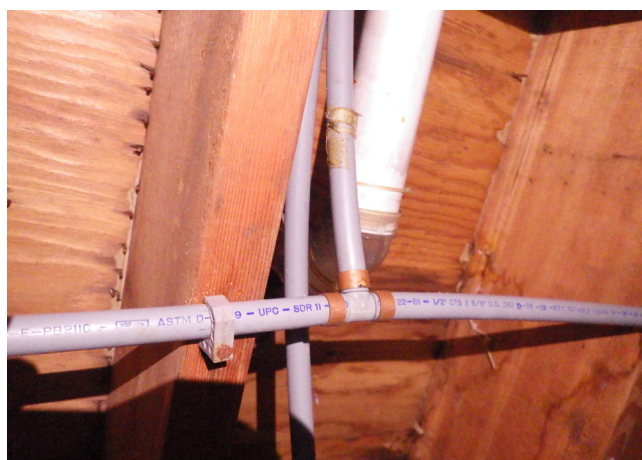
*Example of polybutylene piping used for in-suite water distribution*

Polybutylene, a grey plastic pipe material, was used for cold and hot water distribution in some residential buildings in the 1980's and 1990's in B.C. The plastic compression fittings on polybutylene pipes have been known to fail prematurely and introduce air into heating systems, causing issues with pumps and heat distribution, in addition to leaks. At a minimum, hire a contractor to replace the polybutylene fittings with metal fittings in multi-unit buildings. Consider hiring a contractor to replace polybutylene pipes with a more durable plastic such as cross-linked polyethylene (PEX) or copper pipes, which are more temperature resistant than plastic. If using PEX, specify low-zinc brass fittings or use engineered plastic fitting components to reduce the risk of dezincification of the fittings. Only use PEX in dark areas to minimize sunlight exposure or recessed indoor

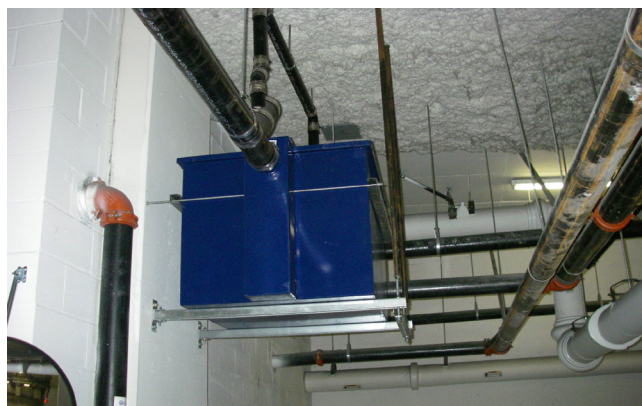
*Example of a multichambered flow through grease trap suspended from the structure above*

**Grease traps** and separators are common in restaurants and commercial applications, but they can also be installed in residential buildings to intercept grease and solids before they build up. Clean out grease traps as required before they reach 25% capacity (the frequency will depend on the building).

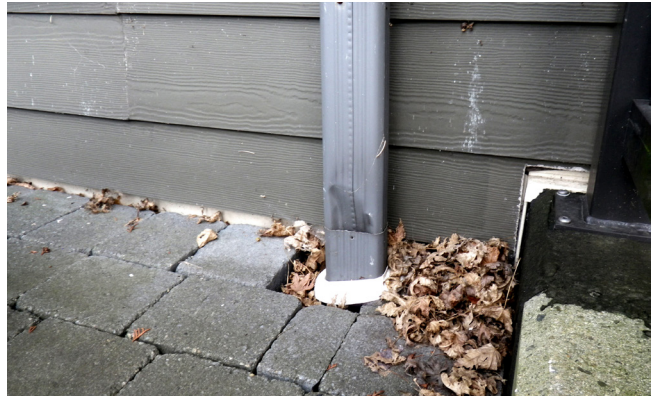
*Example of a downspout leading to a perimeter drain*

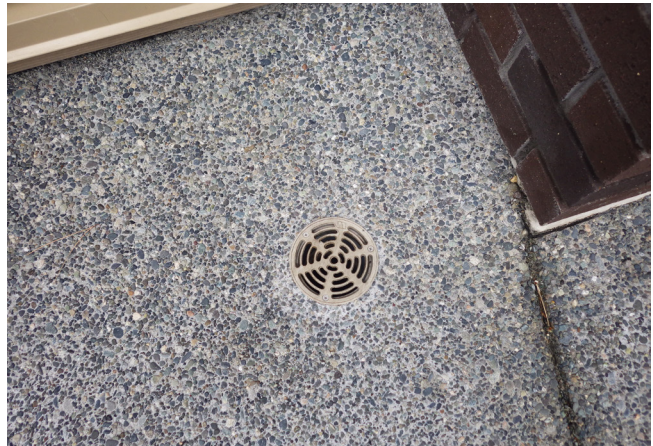
*Example of a drain on a roof deck*

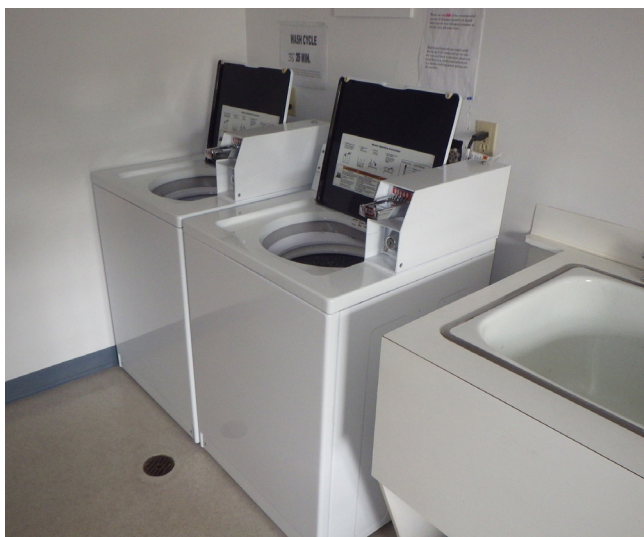
*Example of a communal laundry room with a built-in drain in case of washing machine back-up, overflow or leaks*

Install a drain pan beneath communal washing machines to catch leaks due to washing machine overflow or hose failure. In some cases, the drain pan can be connected to a drain pipe to move water away from the area. It is common to have a floor drain built into the communal laundry room. Be aware of existing drain pans' condition. Replace them at the first signs of breaking or cracking since they can deteriorate over time. Similar to washing machines, drain pans may be installed under Heating Ventilation and Air Conditioning (HVAC) equipment.

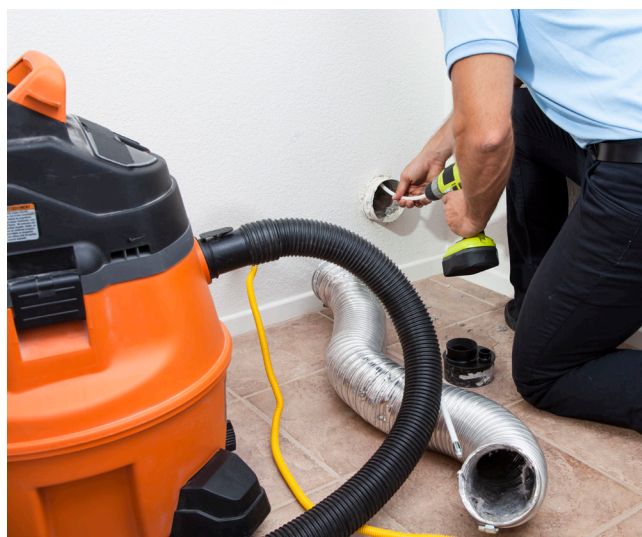
*Cleaning and maintaining dryer exhaust vents*

**Dryer exhaust vents** need to be cleaned and maintained otherwise condensation in ducts can leak and cause water staining and damage. Consult Maintenance Matters No. 14 Avoiding Exhaust Duct Problems for more information.

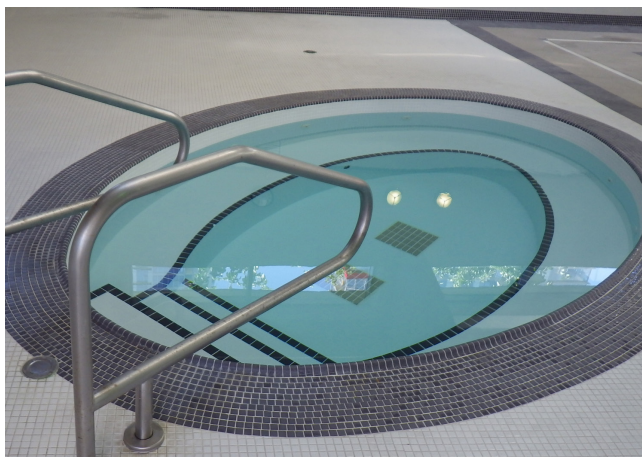
*Example of a hot tub or “spa” in a residential building*

Mop the pool/spa deck as required, checking daily if possible. Check that drains on the deck and in the equipment room are kept clear on a weekly basis. To minimize water damage resulting from pool and spa leaks, inspect their tanks/liners semi-annually to check for signs of distress such as cracks, delamination, spalling and discolouration. Repair as needed. Check the filtration system semi-annually for signs of leaks, misaligned parts, and corrosion. Clean the area around the pumps and filters monthly, and plan on hiring a contractor to replace the pool and spa heating equipment every 15 years. Plan on hiring a contractor to replace the water circulation system every 15 years, with component repair/replacement occurring every five years. Liners for pools and spas must be inspected annually for leaks and fissures.
